LOTAMB Skid Training 2012

Initial Investigations Exercise

Site 1

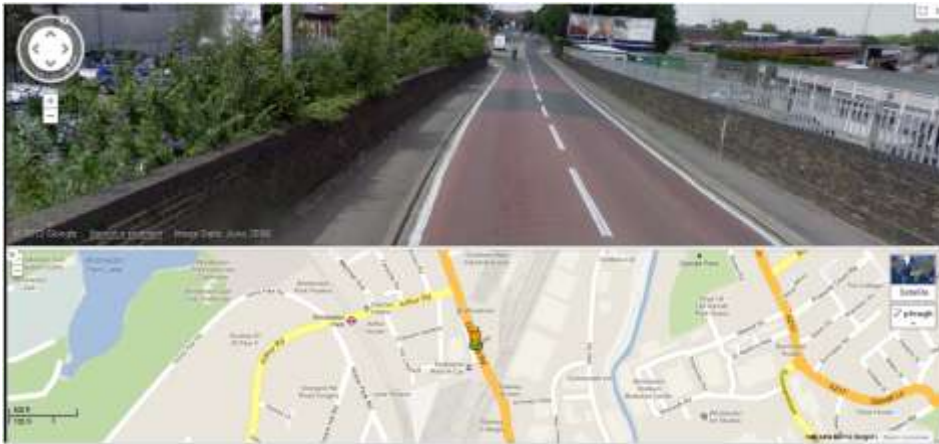
Image 1: Approach to First Junction

- Low Skid Resistance on Coloured Surfaces

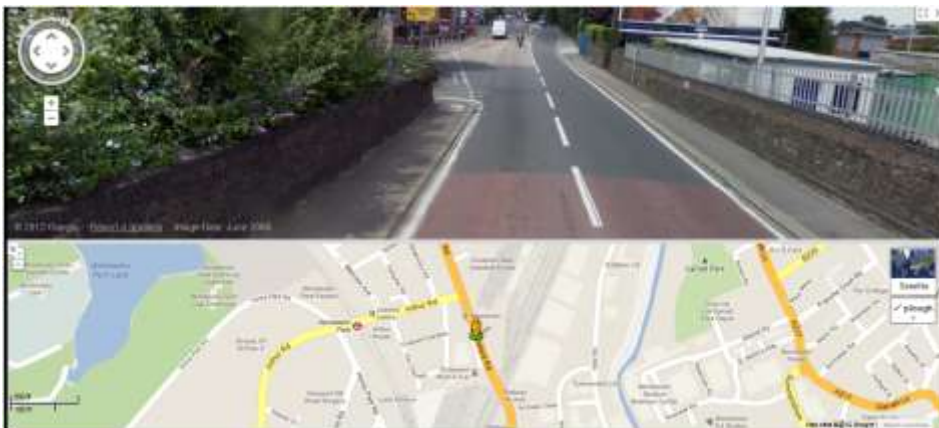
Image 2: Approach to First Junction

- First junction is concealed and there is poor sight distance from that approach

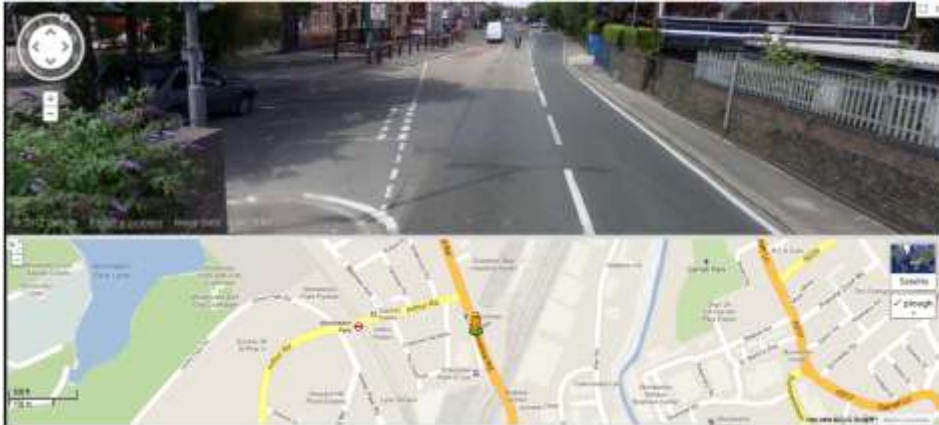
Image 3: First Junction

- Poor visibility at junction

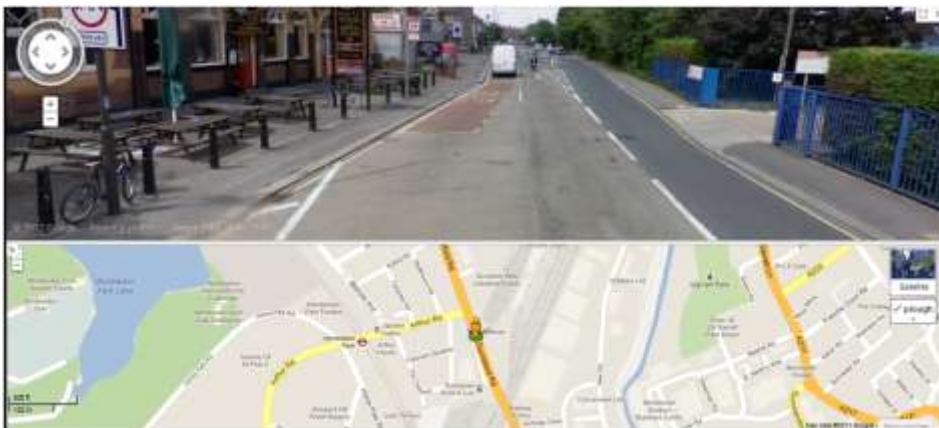
Image 4: Approach to Second Junction

- Bus Stop/Pub/Seating = Lots of people movement
- No crossing facilities except at the next junction

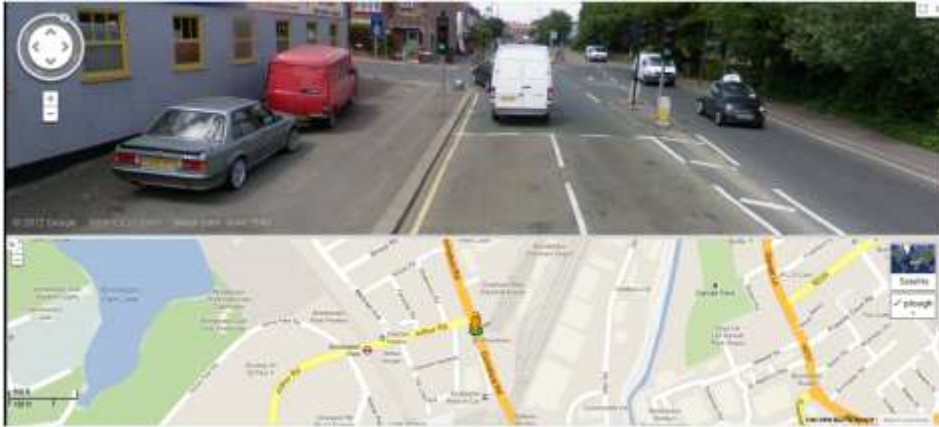
Image 5: Second Junction

- Old HFS Surface

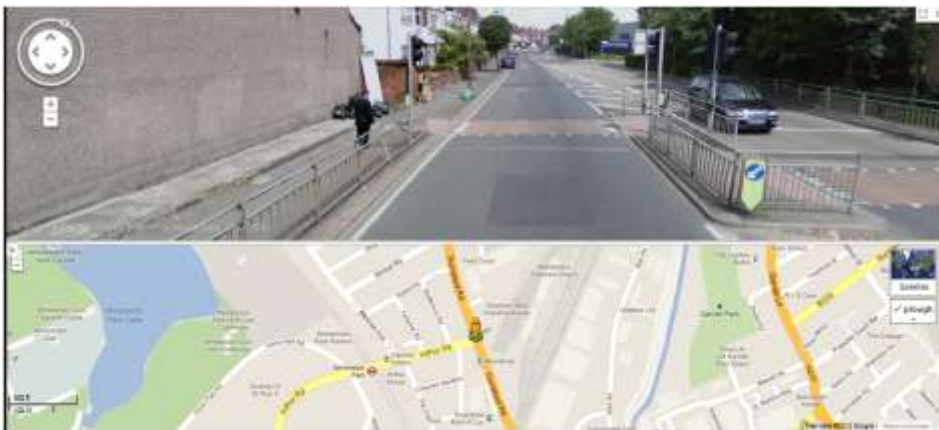
Image 6: Pedestrian Crossing Beyond Junction

- Approach to Crossing was not included in the PMS as a separate site category

- Set up Approach to Crossing site category in the PMS
- Recommendation is to undertake the secondary field investigation

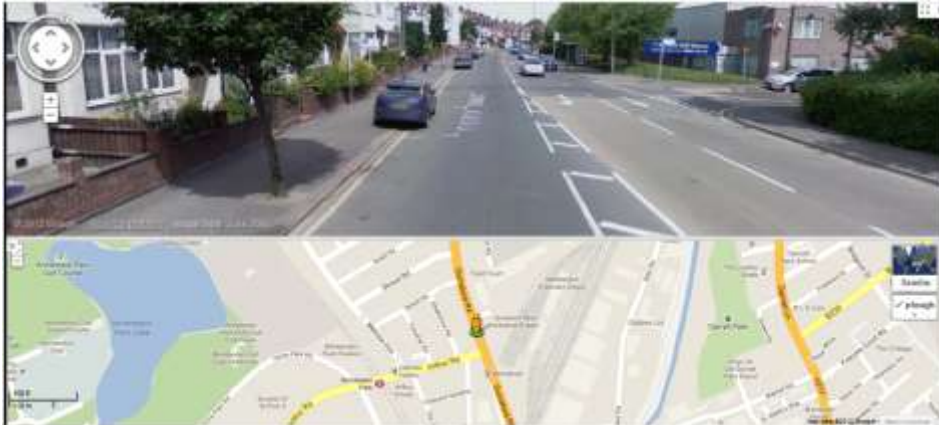
Image 7: Approach to Third Junction

- Poor location for disabled parking bays

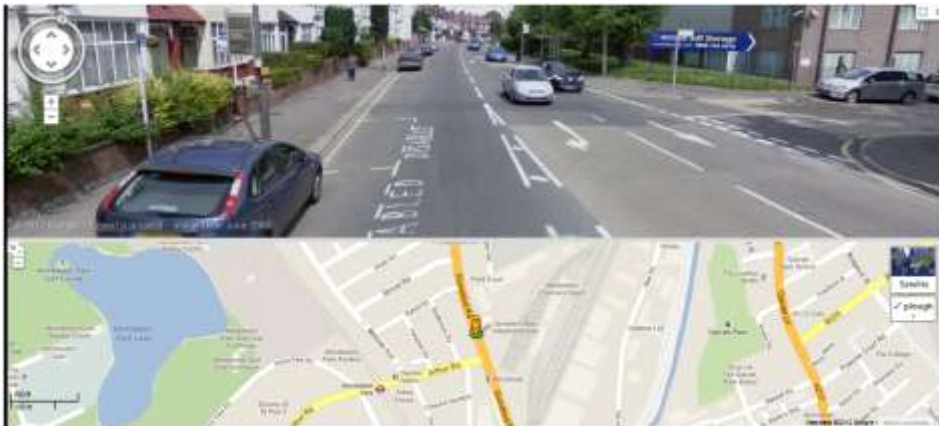
Image 8: Third Junction

- Disabled parking bays by the junction, queuing hazard

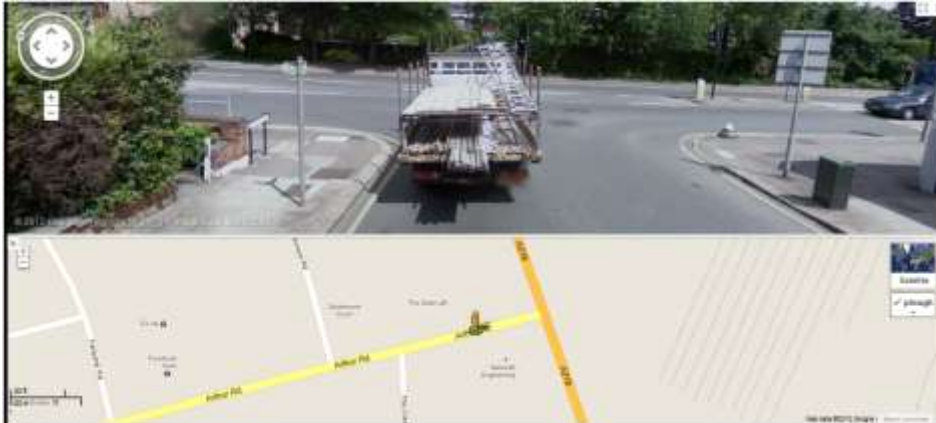
Image 9: Approach to Second Junction from the Side Road

- Bevelled crossing only on one side

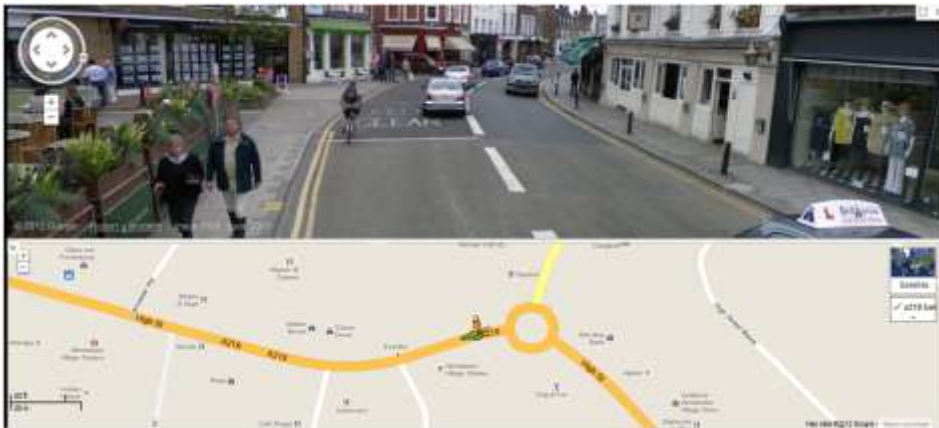
Image 10: Driveways, End of HFS Surface

- Surface appears to be relatively new
- HFS section before the approach to crossing

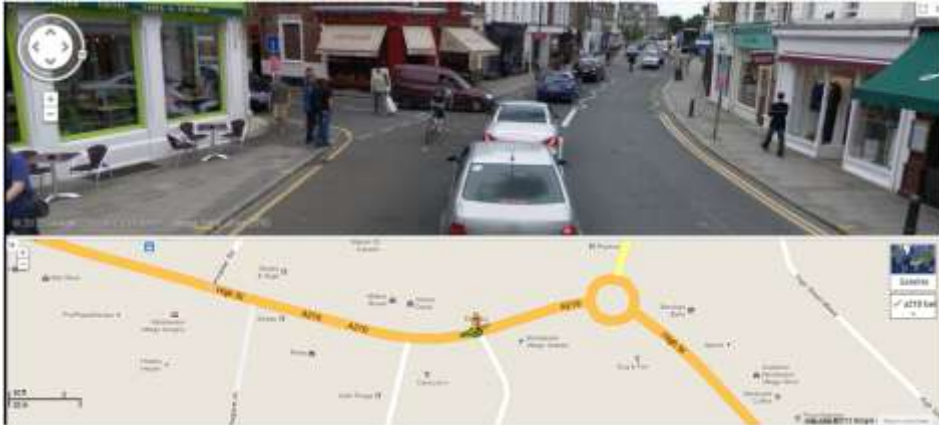
Image 11: Approach to a Junction

- A busy section with lots of events/hazards

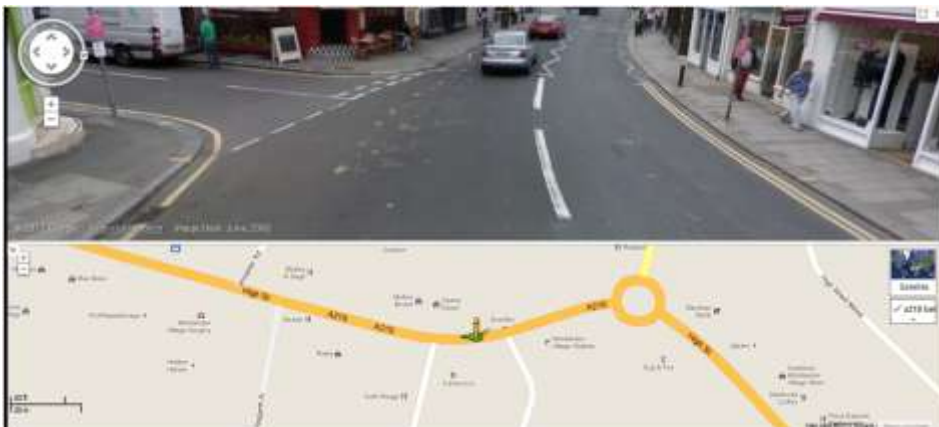
Image 12: Junction and Contaminated Surface

- Temporary surface contamination evident
- Temporary surface condition could be the reason for low Skid Resistance

- Check SCRIM data from previous surveys and check if it is a big drop
- Is the material achieving the required IL for Approach to Crossings
- Check the performance of the particular material at this site as well as other sites installed with the same material
- Recommendation is to monitor the site

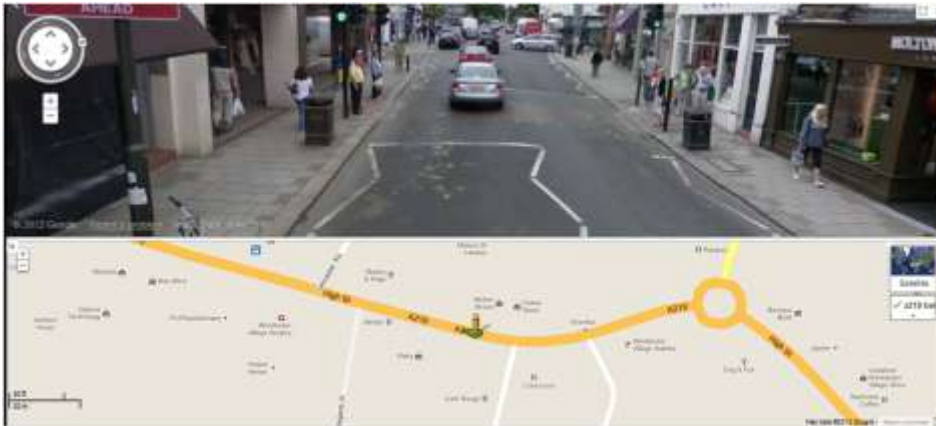
Image 13: Crossing and Contaminated Surface

- No HFS on approach to the crossing

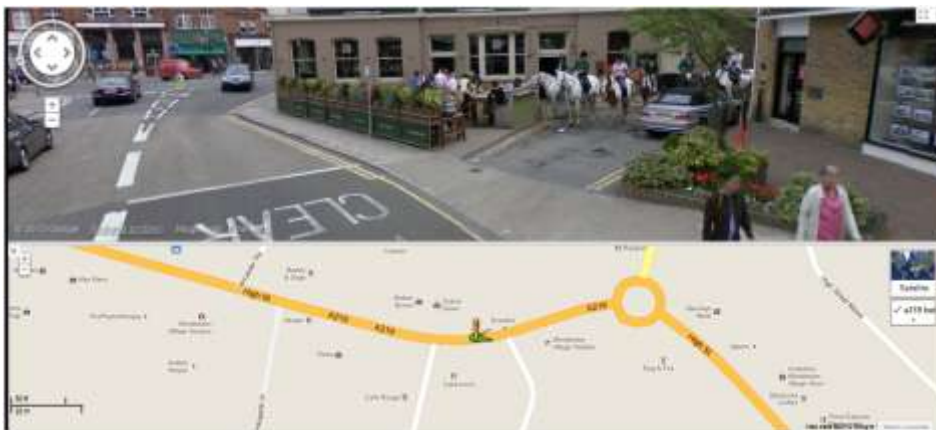
Image 15: Stables

- Stable/Horses the likely source of contamination
- Is temporary contamination the reason for low SR?

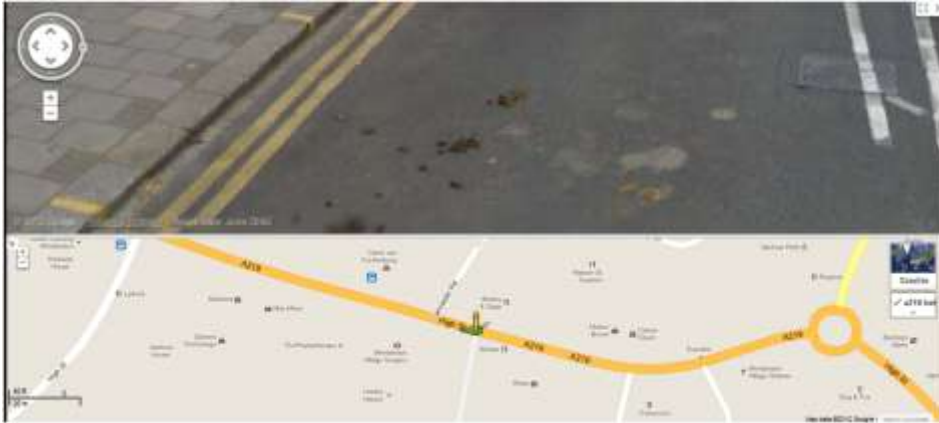
Image 14: Contaminated Surface, Temporary

- Is this a regular occurrence?

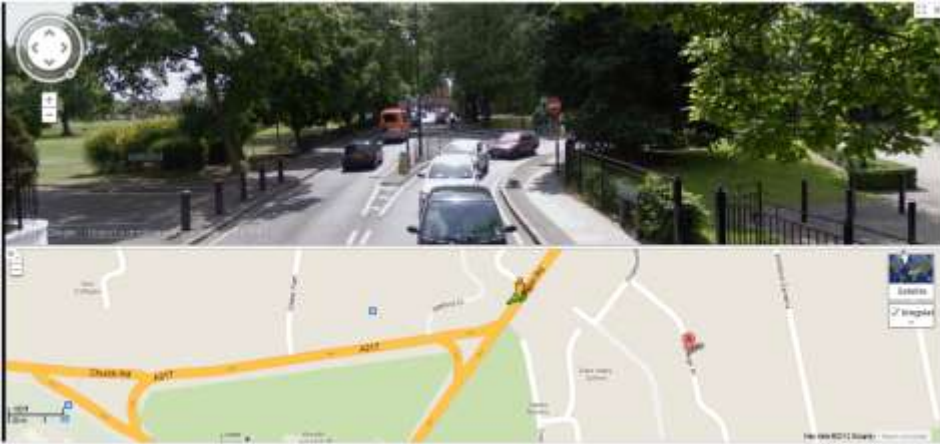
Image 16: Approach from North

- Speed of straight-through traffic could be high, but no advisory sign for traffic to slow down

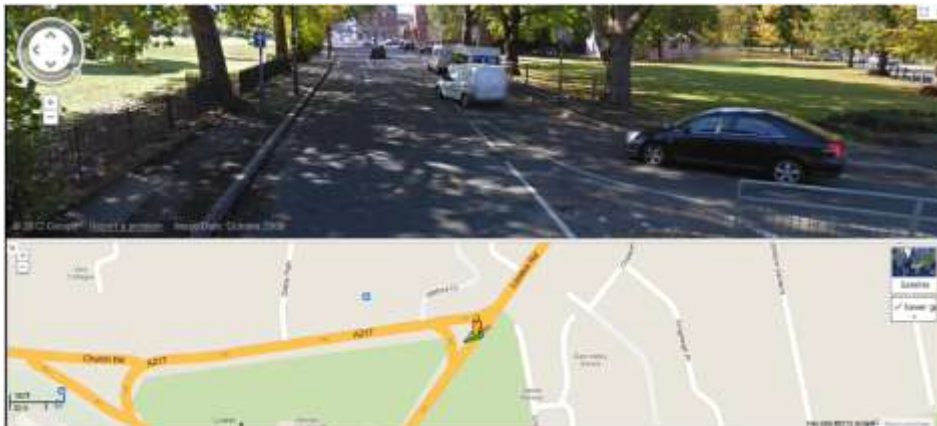
Image 18: Exclusive straight through lanes, hence Non-Event

- Traffic merging

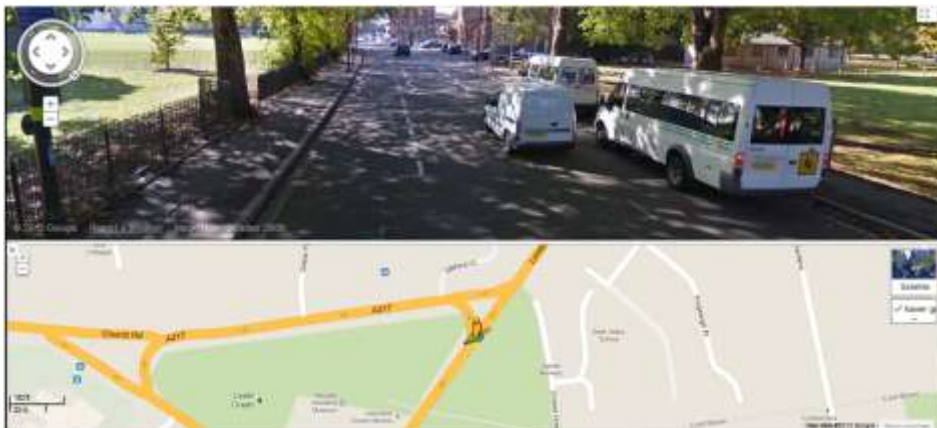
Image 19: 3-lane One way

- New pedestrian crossing installed
- Needs to be entered into PMS

- Recommended to add the new Approach to Crossing into the PMS and reassess priorities
- Site will be divided into two parts – the first part would remain as Non-Event and may not be SCRIM deficient
- The Approach to Crossing (50m) could then be SCRIM Deficient, but with no accidents, therefore very likely Priority 2
- Undertake Secondary Investigation if necessary

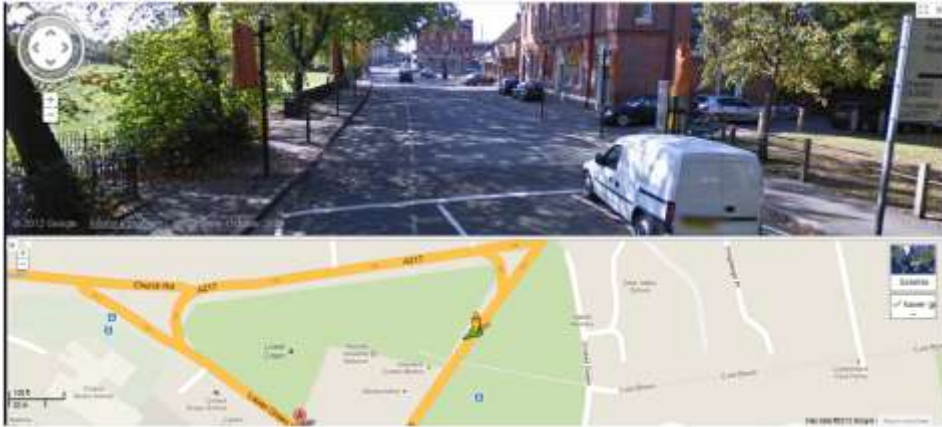
Image 20: New Pelican Crossing

- New pedestrian crossing location
- High risk of pedestrian collisions

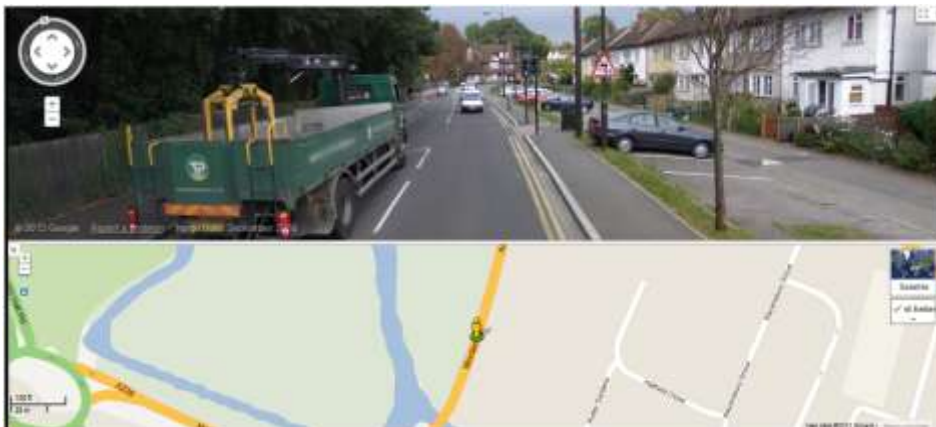
Image 21: Approach from South, Slippery Road Sign

- Slippery Road sign already in place

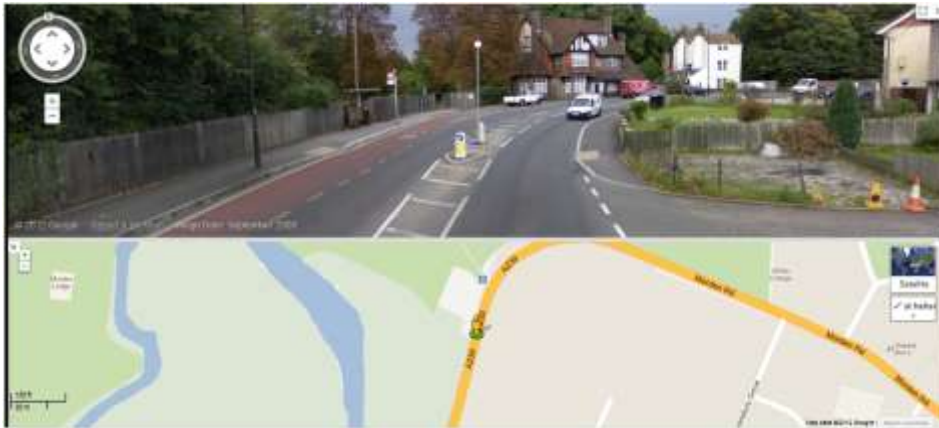
Image 22: Approximate Start of Site

- Surface appears to be worn
- Site is SCRIM deficient in both directions

- Check Skid Resistance in both directions – both directions deficient
- Recommendation is to undertake a Secondary Investigation

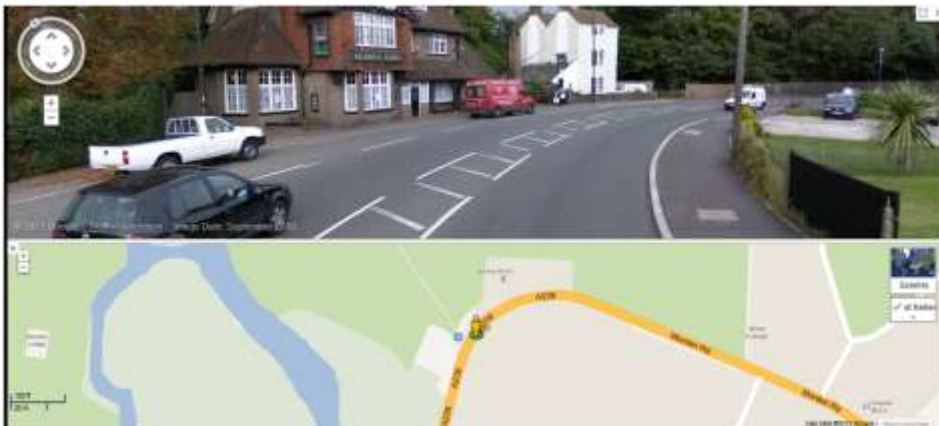
Image 23: Smallest Radius

- Bend <100m radius
