LOTAMB Skid Training 2012

Initial Investigations Exercise

Site 1

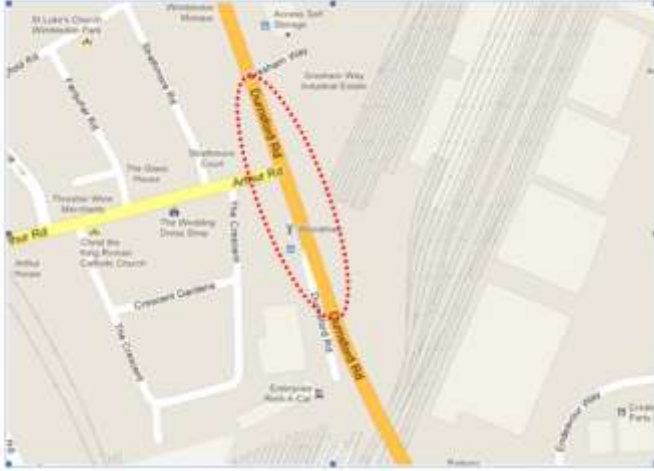
The Site (Locality Plan and Images)

Priority 1 (SCRIM Deficient with Wet Accidents)

Series of Approaches to Junctions

218m long

- Set up Approach to Crossing site category in the PMS
- Recommendation is to undertake the secondary field investigation

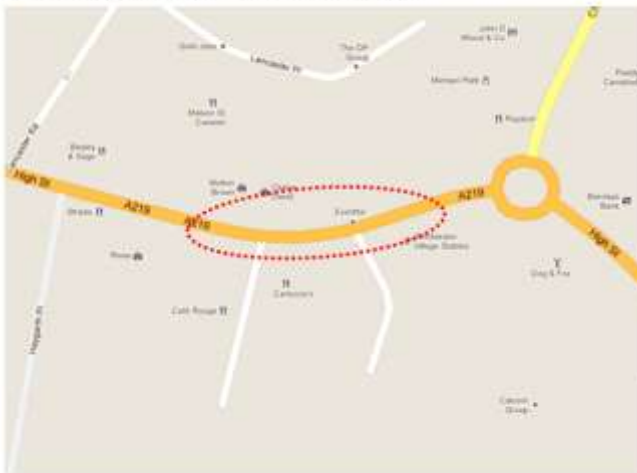
The Site (Locality Plan and Images)

Priority 2
(Significantly
SCRIM Deficient
but no Wet
Accidents)

An Approach to a
Crossing

- Check SCRIM data from previous surveys and check if it is a big drop
- Is the material achieving the required IL for Approach to Crossings
- Check the performance of the particular material at this site as well as other sites installed with the same material
- Recommendation is to monitor the site

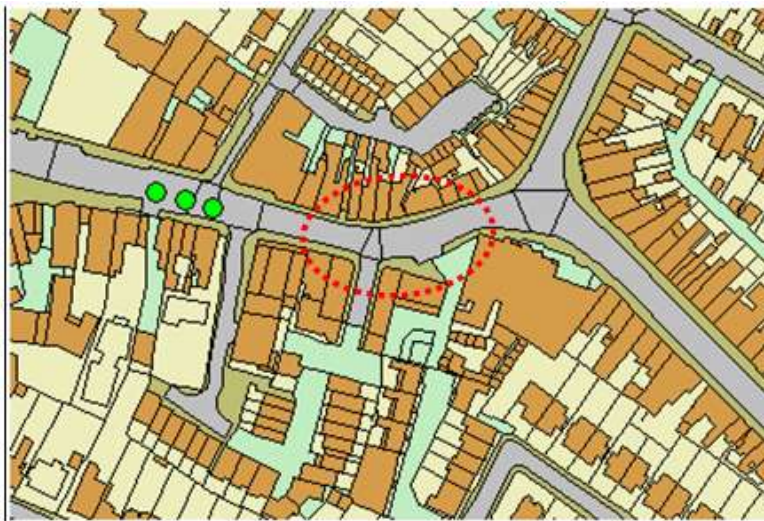
Site 2: Accident Details

- A busy section with lots of events/hazards
- Surface appears to be relatively new
- HFS section before the approach to crossing
- No HFS on approach to the crossing
- Temporary surface contamination evident
- Stable/Horses could be the source of contamination
- Temporary surface condition could be the reason for low Skid Resistance
- Is this a regular occurrence?

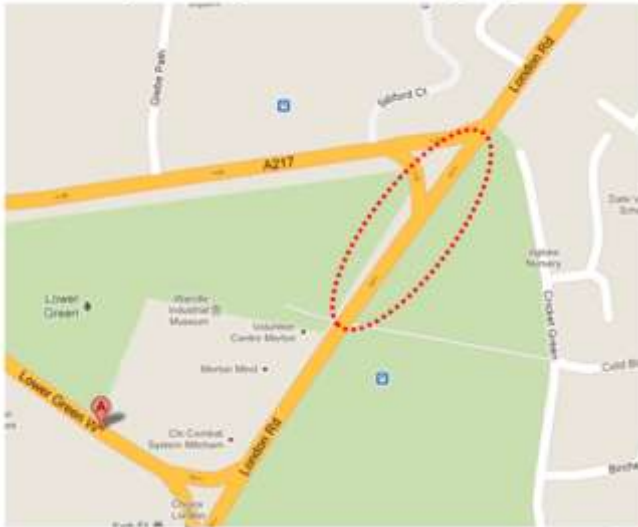
The Site (Locality Plan and Images)

Priority 3 (Slightly above IL, but with Wet Accidents)

Single Non-Event section, One-way

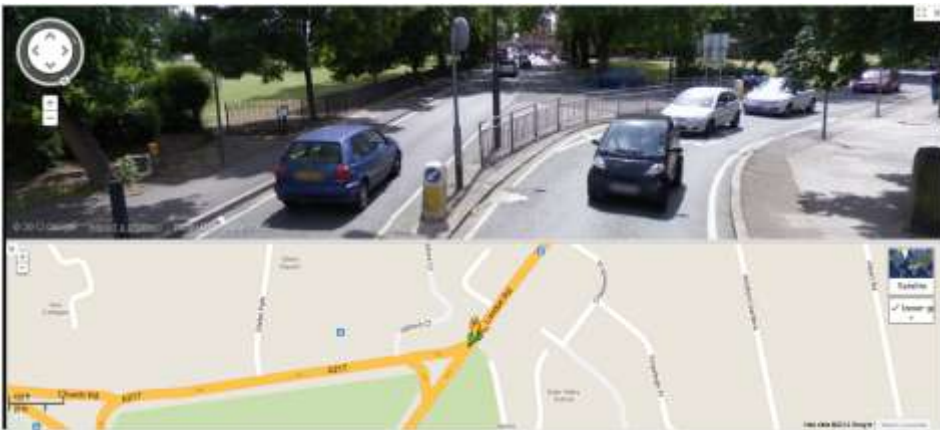
Image 17: Approach from North

Image 18: Exclusive straight through lanes, hence Non-Event

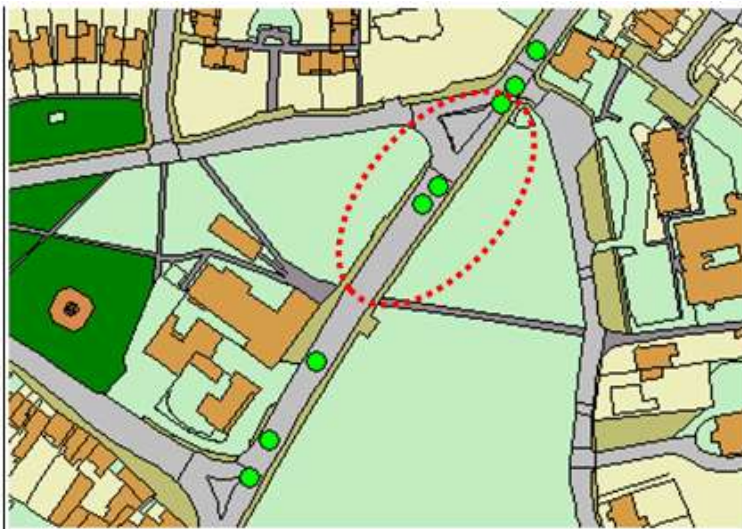
Site 3: Accident Details

Accident 1	
Accident Date	09/08/2008
Accident Time	00:00
Light Conditions	DAYLIGHT: STREET LIGHTING UNKNOWN
Road Surface Condition	WET / DAMP
Vehicle Location	
Accident Description	IT IS UNCLEAR HOW ACCIDENT HAPPENED BUT V1 SPUN INTO SOME BOLLARDS AFTER THE COLLISION
Severity	SLIGHT
Contributory Factor	
Skidding and Overturn

Accident 2	
Accident Date	30/11/2007
Accident Time	00:00
Light Conditions	
Road Surface Condition	DRY
Vehicle Location	
Accident Description	PEDESTRIANS CROSSED IN PATH V1
Severity	SERIOUS
Contributory Factor	
Skidding and Overturn

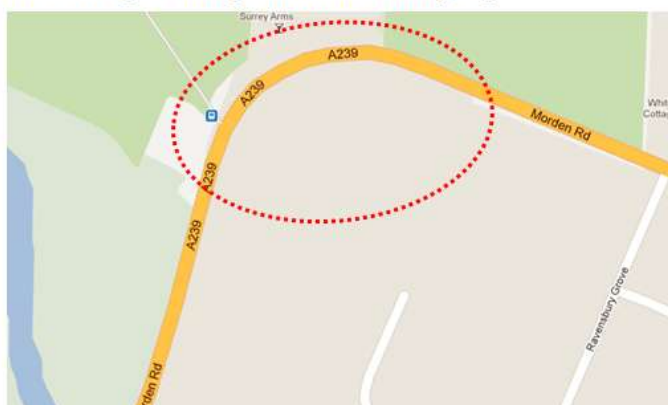
The Site (Locality Plan and Images)

Priority 1
(SCRIM Deficient
with Wet
Accidents)

Single <100m
Bend
